Docket No. 217 – Development and Management Plan Inspection

Northeast Utilities Service Company Certificate of Environmental Compatibility and Public Need for the construction of a 345-kV electric transmission line and reconstruction of an existing 115-kV electric transmission line between Connecticut Light and Power Company's Plumtree Substation in Bethel, through the towns of Redding, Weston, and Wilton, and to the Norwalk Substation in Norwalk, Connecticut.

Date: August 30, 2006

Location: 345kV Underground Route

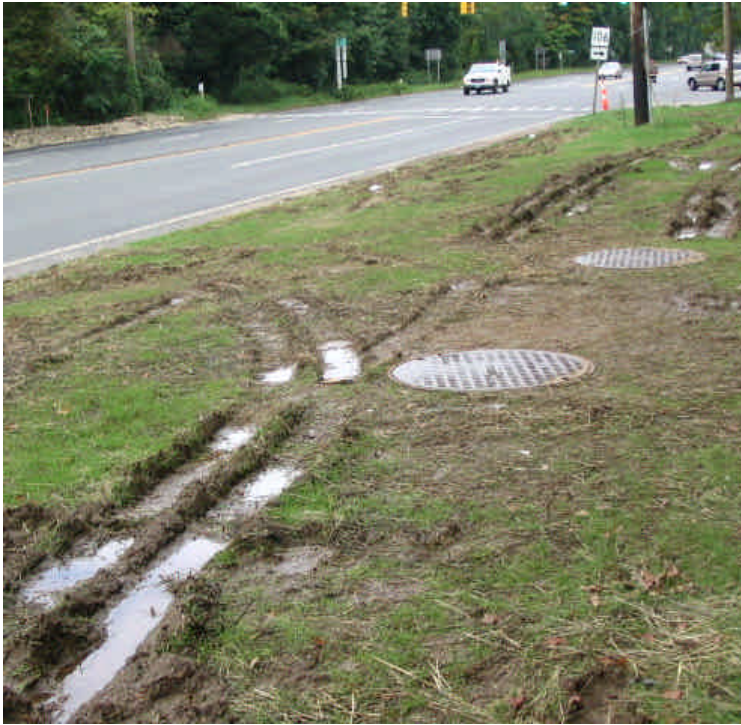
345kV: Photo on the left shows where access was needed at the temporarily restored Wilton Corp Park vault site. Continue to restore permanently when feasible. Photo on the right shows the storage yard across from Old Highway Rd which was recently graded. 8/30/06

- The vault area at Wilton Corp Park was temporarily restored but access created new tracks in the soil. 8/30/06	-Restore as necessary and monitor for final stabilization. 8/30/06	-Needs attention when feasible
Rt. 107	- Landowner activities near the storage area near #848 (Rt.7) are directly affecting wetlands, including placing sediment on the banks of the swales. 3/15-8/30/06	-The sediment placement and landowner activities are outside of project jurisdiction. 4/6-8/30/06	-N/A

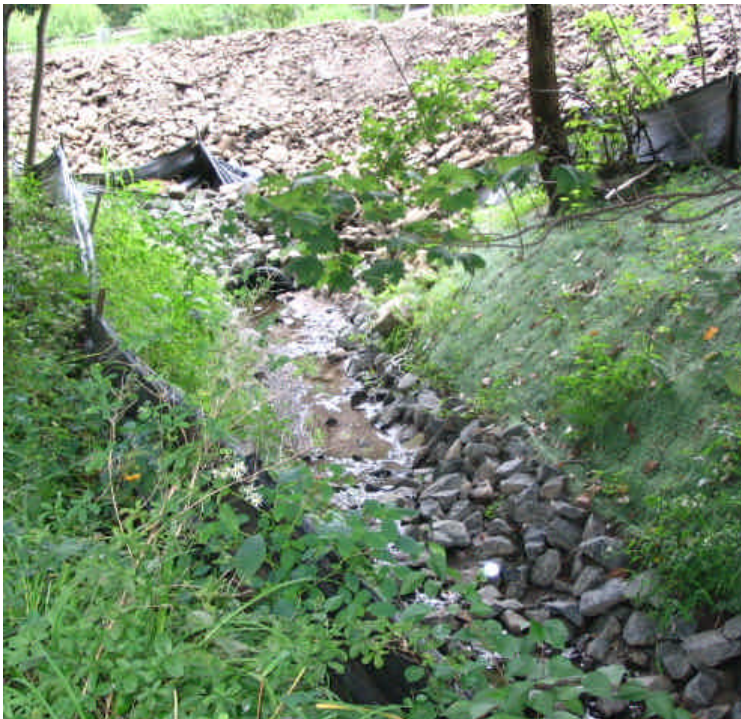
Photo on the left shows the swale near Old Danbury Rd. Silt fence remains crushed by adjacent stone. Photo on the right shows some tire tracks in the restored School Rd site. Safety fence is now secure along the entire edge. 8/30/06

- The silt fence near the swale on Old Danbury Rd. was buried in one spot by stone due to recent grading in the area. Areas upgradient remain disturbed. 8/16-8/30/06	-Grade and restore the area as soon as possible to remove the potential for erosion. 7/19-8/24/06 Also consider removing accumulated sediment in the swale. 7/12-8/30/06	-Needs attention when feasible.

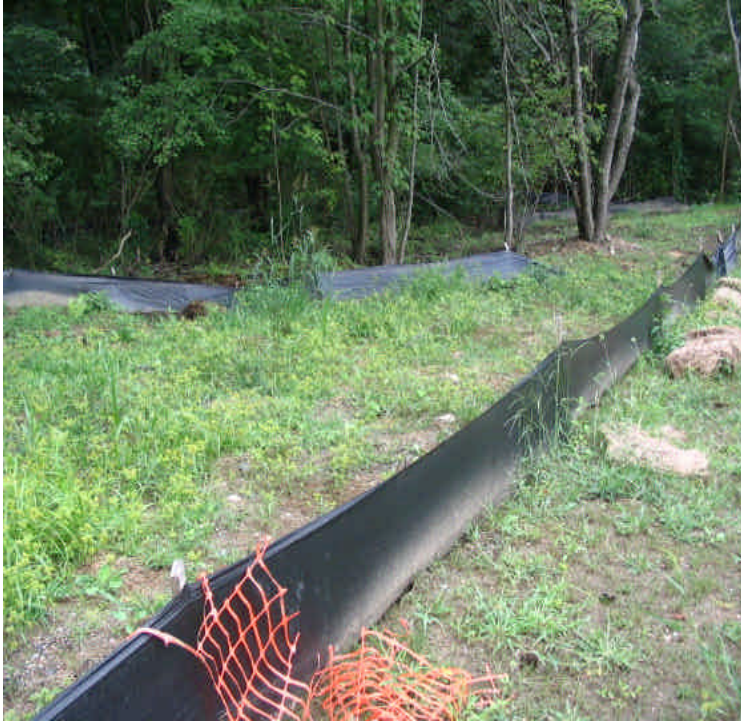
Photo on the left shows the wetland area along the east side of the old HDD site. Vegetation is returning in this area. Photo on the right shows the restored channel within the wetland to the east of the site. Standing water here was not turbid following the rains. 8/30/06

Adjacent Wetlands and Waterways	<p>-Adjacent areas of wetland were restored around the HDD site. Vegetation is slowly returning. 8/30/06</p> <p>-Standing water in the swale here was not turbid following the rains. 8/30/06</p>	<p>-Continue to monitor for vegetative cover and stabilization.. 8/30/06</p> <p>-None at this time. 8/30/06</p>	<p>- N/A</p> <p>-N/A</p>
Staging, Storage, and Parking Areas	<p>- Disturbance in the equipment storage yard on the property south of the Rt. 7 & 107 intersection is mostly due to landowner activities. 3/15-8/30/06</p> <p>-The possible spill in the gravel here was removed and most of the equipment and materials were</p>	<p>- In general, materials should be placed appropriately in storage areas or immediately adjacent to work each night. No potentially spillable materials should be left behind. Equipment should not be placed near resource areas.</p> <p>-None at this time.</p>	<p>-N/A at this time</p> <p>- The spill was</p>

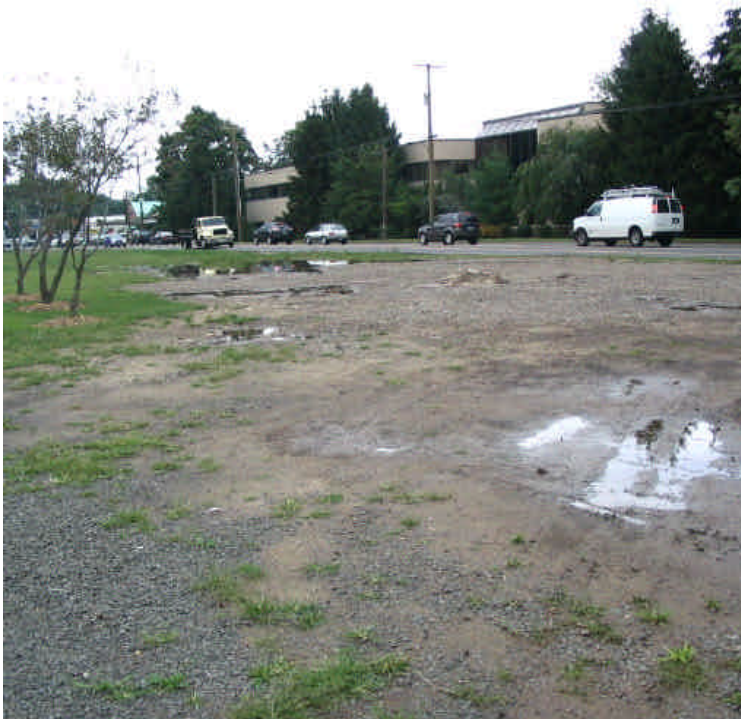
Photo on the left shows a large, bare soil area requiring more restoration in front of the Wilton High School tennis courts along Rt 7. Topsoil, seed and mulch will be necessary. Photo on the right shows recent restoration at the vault location near Allen's Meadow park. 8/30/06

- A large bare soil area remains near the Wilton HS tennis courts. Previous attempts had been made to restore the area but were unsuccessful. 8/30/06	- Loam, seed and mulch this area. Also, evaluate the grading since water is ponding up here. 8/30/06	- Needs attention when feasible.

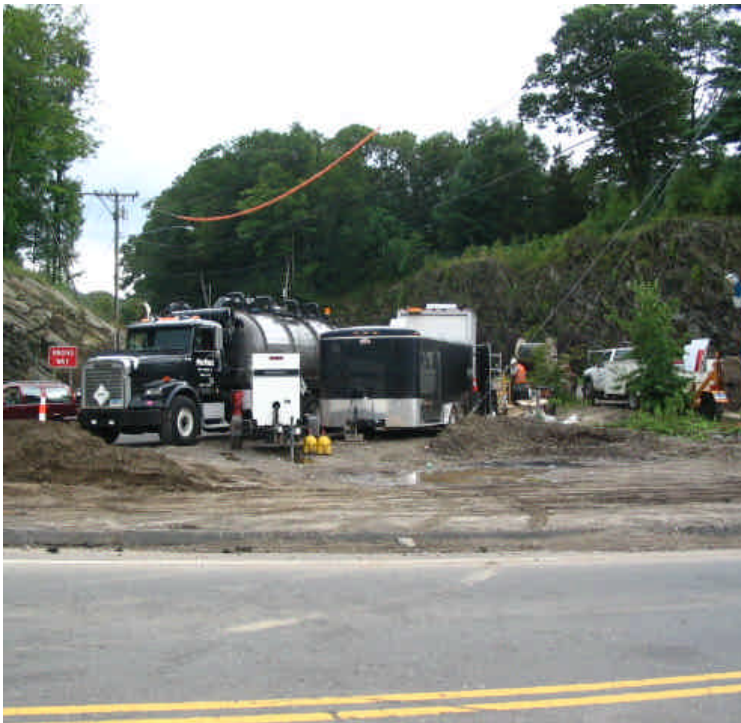
Photo on the left shows continuing work at the vault at the Rt 107/7 intersection. Adjacent catch basins still need controls due to the exposed soil and stockpiles. Photo on the right shows a view of the silt fence installed at the Gilbert & Bennett lot. Seed and mulch are still needed here along the slope. 8/30/06

- Catch basins near the Rt. 107 & 7 intersection do not have filters/ controls in	- Install controls in the catch basins and restore the island when access is	- Needs attention

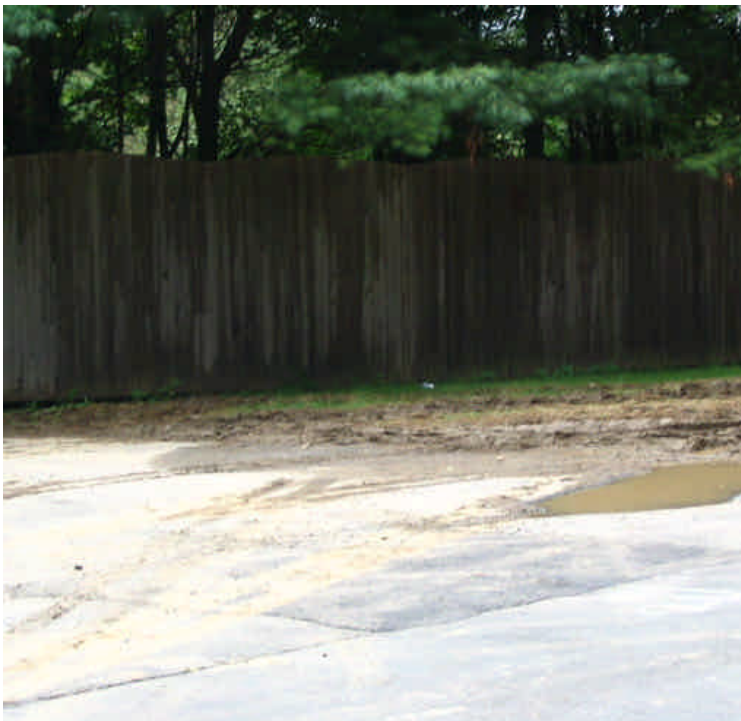
Photo on the left shows where additional utility work north of the Georgetown Deli disturbed an area recently restored by the project. This resulted in run-off and tracking to the street. Photo on the right shows good proactive controls for spill prevention at Archers Lane where oil tanks were being filled for the project. 8/30/06
